⚠ MANUAL AMENDMENT - PAGE 15

⚠ MANUAL AMENDMENT - PAGE 25

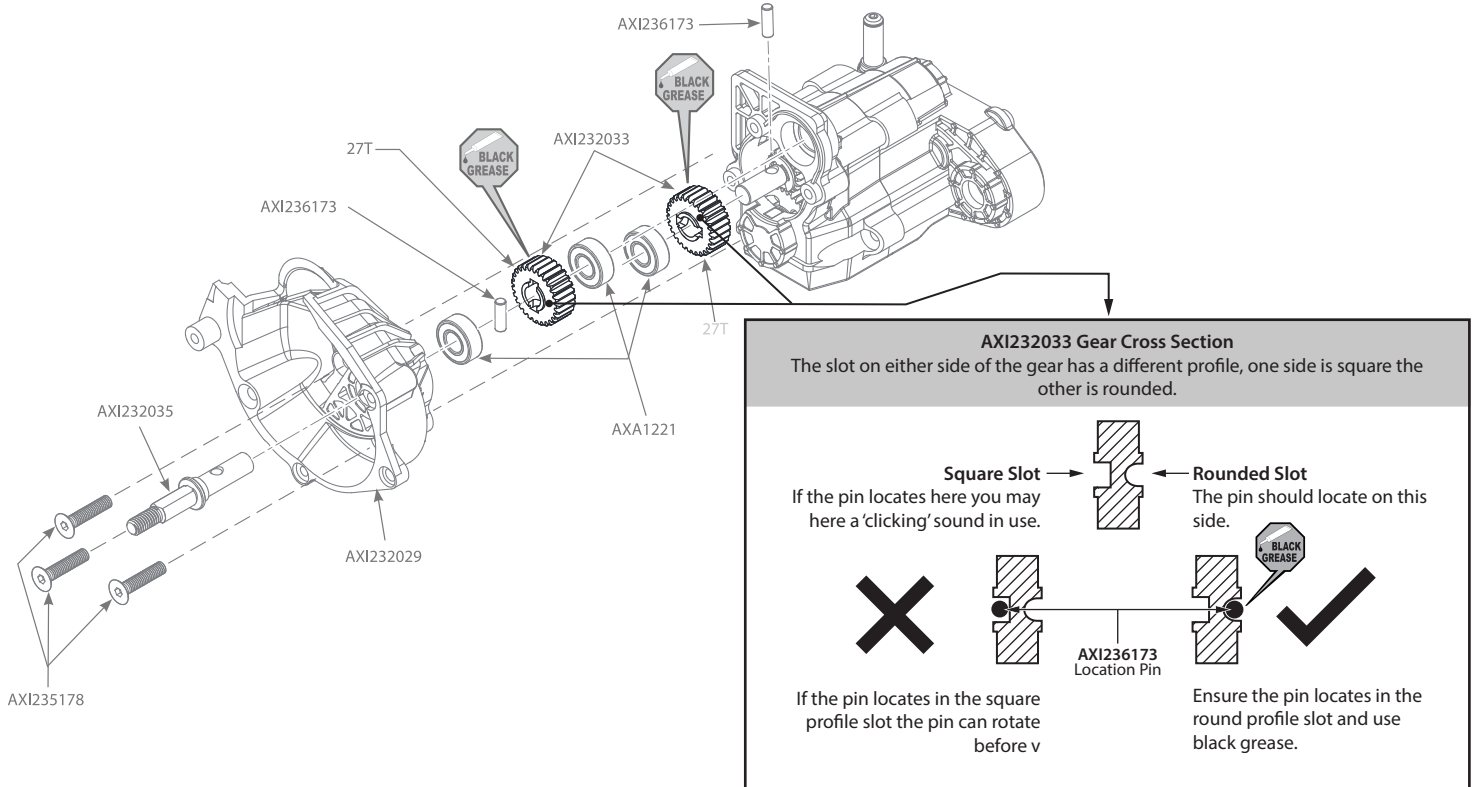
If you are noticing a 'clicking' sound whilst driving your Axial SCX10 III then it is possible that the gears (AXI232033) on page 15 of the manual have been installed incorrect. Carefully disassemble the car, remove the transmission and check the gears are orientated correctly so that the round pin locates within the rounded slot and not the square slot. Add additional black grease within the pin slot to further dampen the backlash that occurs.

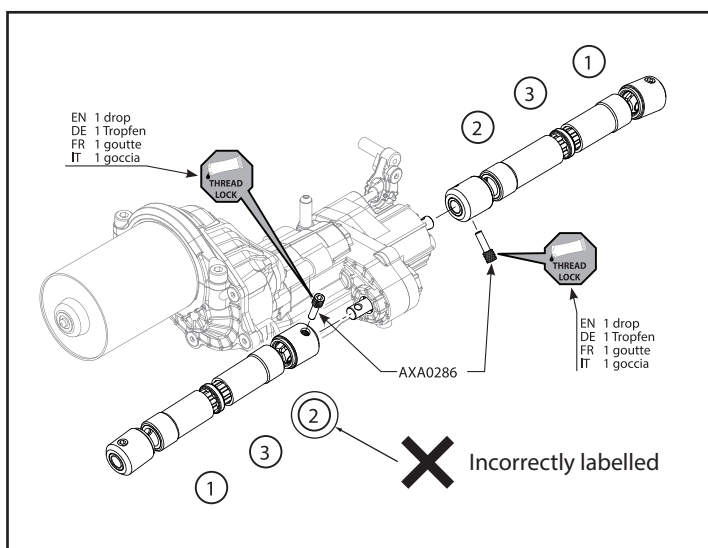
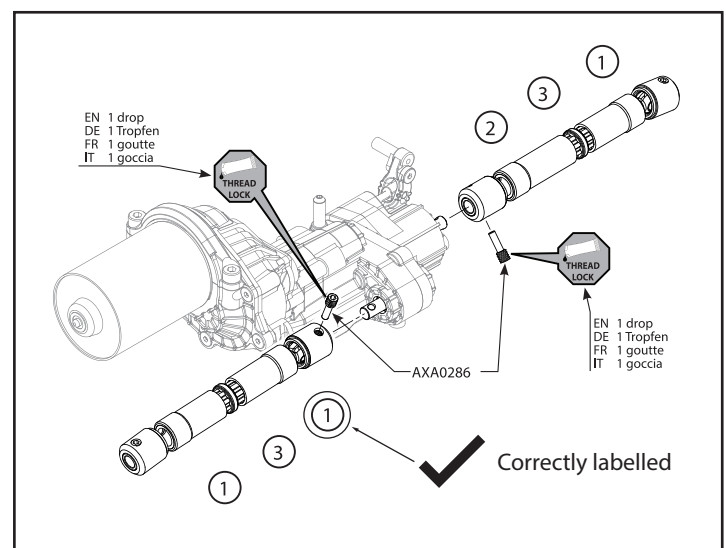
On page 25 of the instruction manual there is an incorrectly numbered part on the driveshaft assembly/installation on the second diagram.
